Manhole Inspection Summary

Manhole # S69K__002MH

Insp Date: 1/30/08 11:15 AM

Location Address: **6705 O'Donnell St.**

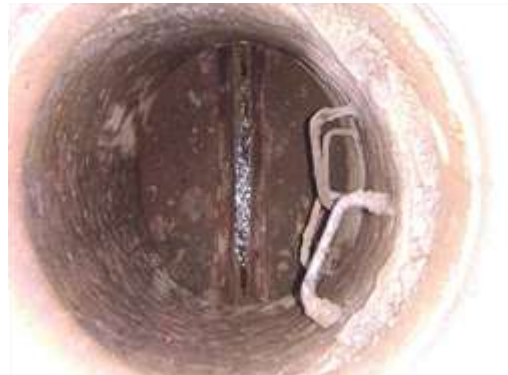
Top View

Frame Offset: **1.5** (in.) Condition: ☐ Sound ☒ **Cracked** ☐ Leaks

Condition: ☐ Sound ☐ Cracked ☐ Root Intrusion ☒ **Loose Brick** ☐ Deteriorated

Infiltration: ☐ None ☒ **Joint** ☐ Cracks ☒ **Mortar** ☐ Roots ☐ Wall
